SCREENING SITE INSPECTION REPORT
FOR

MACON COUNTY LANDFILL #2

DECATUR, ILLINOIS

DECEMBER 26, 1990

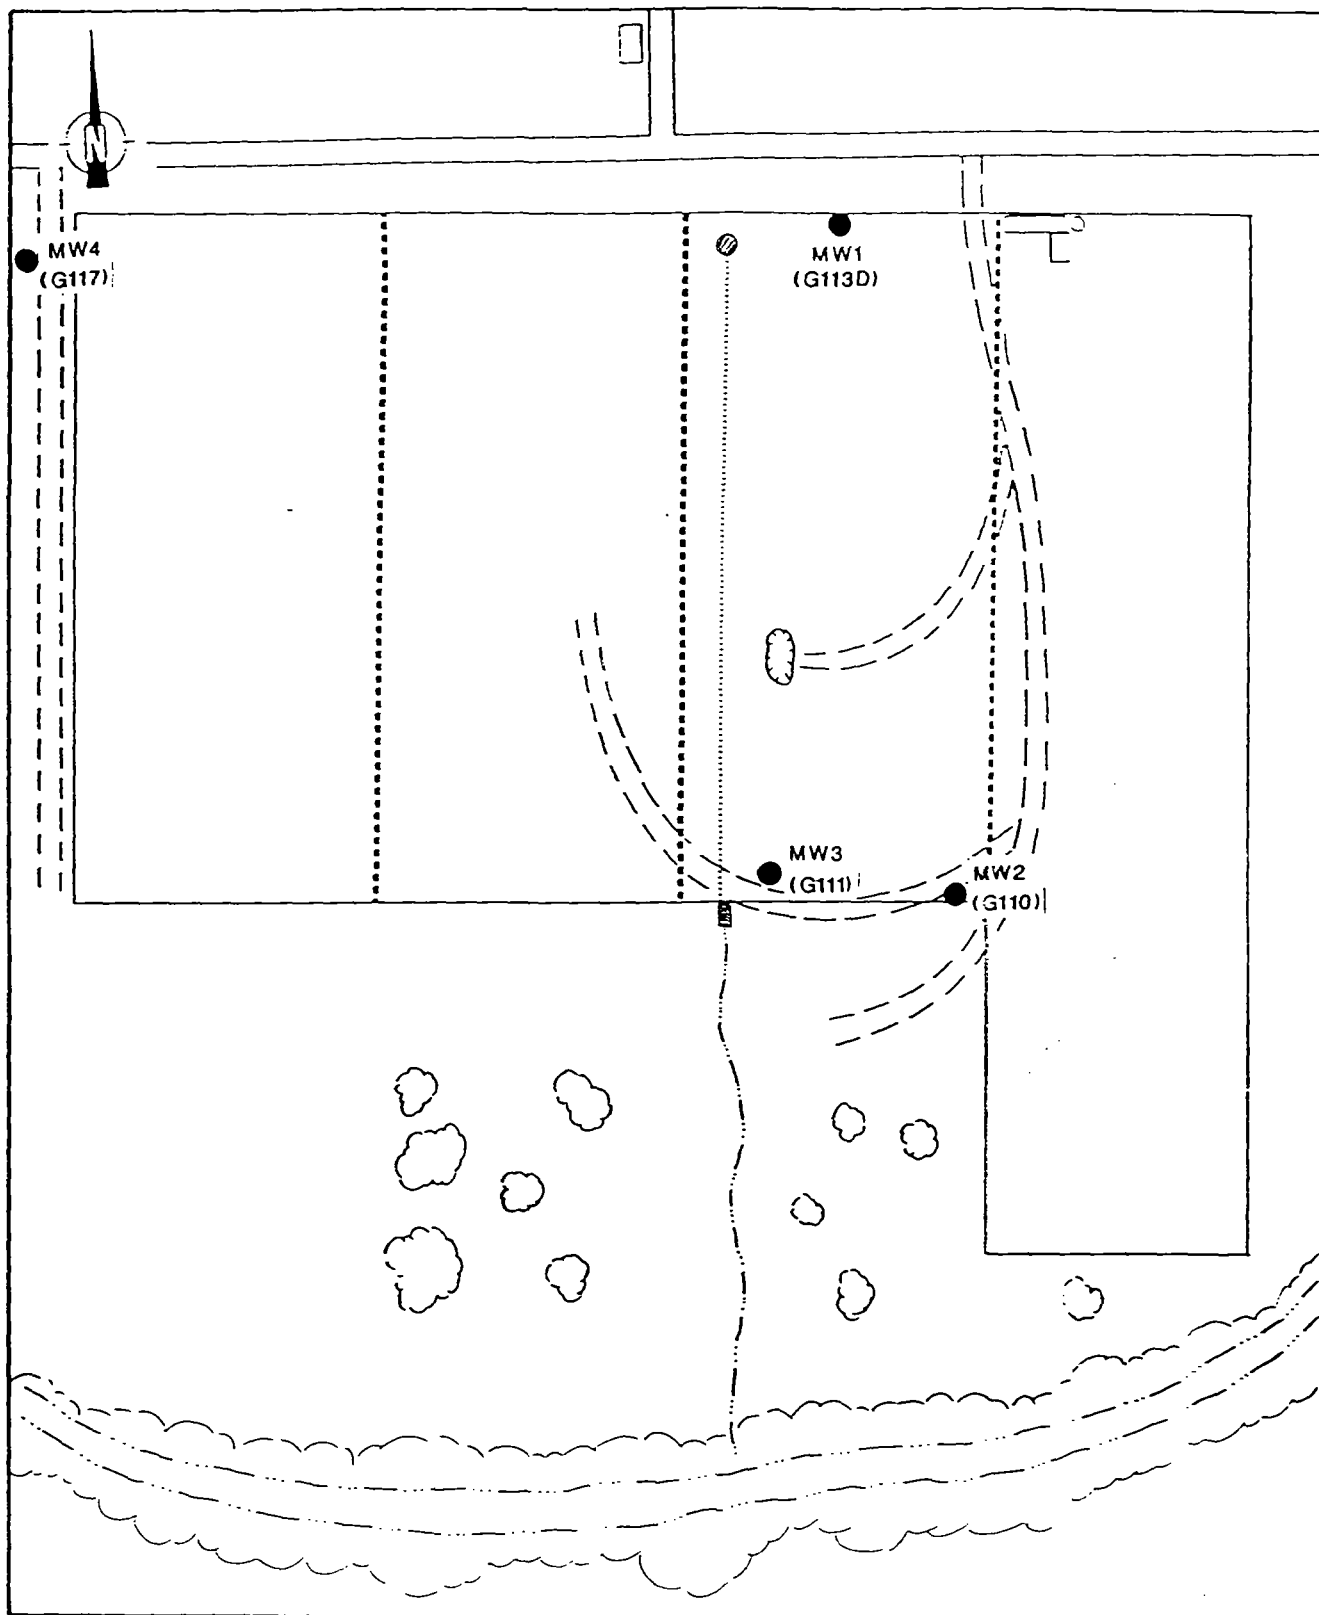
FIGURE 3-5 MONITORING WELL SAMPLING LOCATIONS

Sample MW2 was obtained from a well (G110) on the south end of the site. Sample MW2-A was also obtained at this location. Sample MW3 was obtained from a well (G111) at the southwest corner of the site. No corresponding sample could be obtained from well MW3 because of the removal of this well since the date of the original inspection. A replacement well for MW3 had not yet been installed.
